CASE STUDY

Project: Drainage interceptor unblocking

Drainage interceptor unblocking

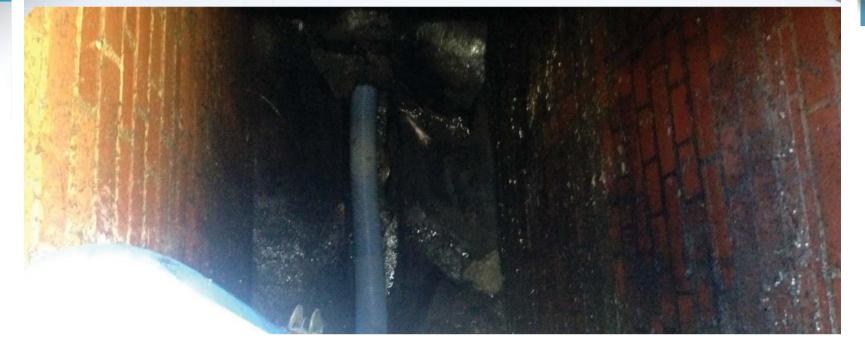
Once the drain was pumped out, the underlying problem was a build-up of hardened scale. These mineral deposits narrow the pipe wall. Materials wrongly disposed of down drains, such as wipes and sanitary products, can snag on scaling. Hardened fats, oils and grease (FOG) can build up behind it, creating fatbergs.

Front cover - A vaccumation hose inserted into the foul drain during the cleaning process. Serious scaling was a main cause of the blockage. This page - The blockage was cleared in time for Camberwell College to reopen.

With its extra power, the Combi jet vac blasted the scale off the pipe. The CCTV drainage survey team confirmed the interceptor was clear and free-flowing. It surveyed all drains feeding into the interceptor to make sure they were clear as well.
