CASE STUDY

Project: Ground penetrating radar survey **Sector:** Leisure management / Local government
Customer: Place Partnership **Location:** Worcester

Ground penetrating radar survey

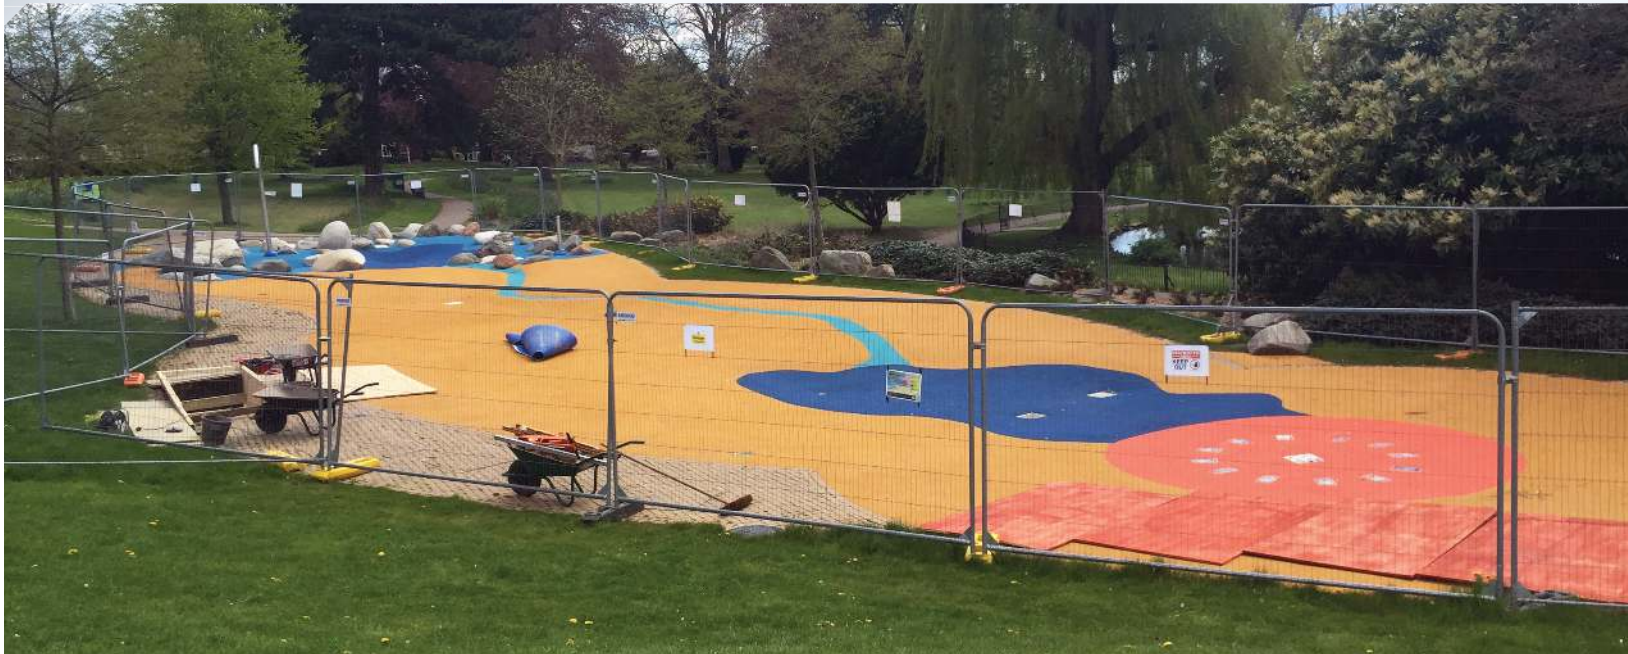
Front cover – The Splashpad attraction had to close because of the ruptured tank. [This page](#) – 1 and 2. The tanks were buried in high ground behind the Splashpad. Without the Ground Penetrating Radar, excavations would have been needed to prepare for the repair.

Splashpad is a popular water play attraction in Worcester. It had to close because one of its water tanks was found to have ruptured. With summer on the way, local councillors were keen to ensure the attraction was repaired and back in action as soon as possible.
