CASE STUDY

Project: Blockage clearance

Client: Leeds United Football Club

Location: Elland Road, Leeds, West Yorkshire

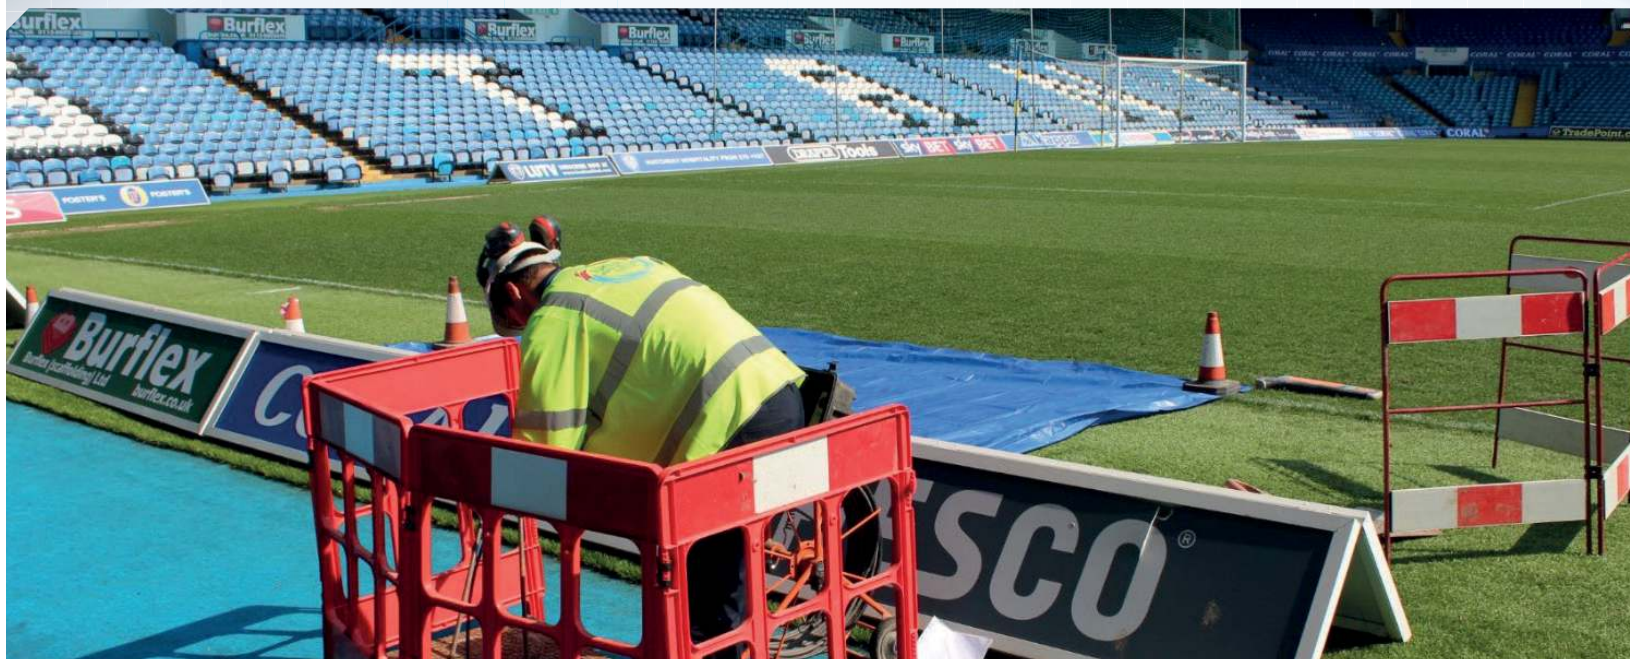
Front cover – The UKDN Waterflow (LG) CCTV drainage survey engineer gets to work capturing HD video of the pitch drainage system.
This page – A Lanes Group jet vac tanker crew prepares to clean the pitch drainage pipes.

About 500m of the perforated plastic 100mm diameter drainage pipe running out to the centre of the pitch was cleaned by the jet vac tanker team, then surveyed using a push-rod camera.
