# CASE STUDY

**Project:** Pipe repair excavation  
**Client:** Claire and Chris Hawes

**Sector:** Domestic  
**Location:** Lewes

## Pipe repair excavation

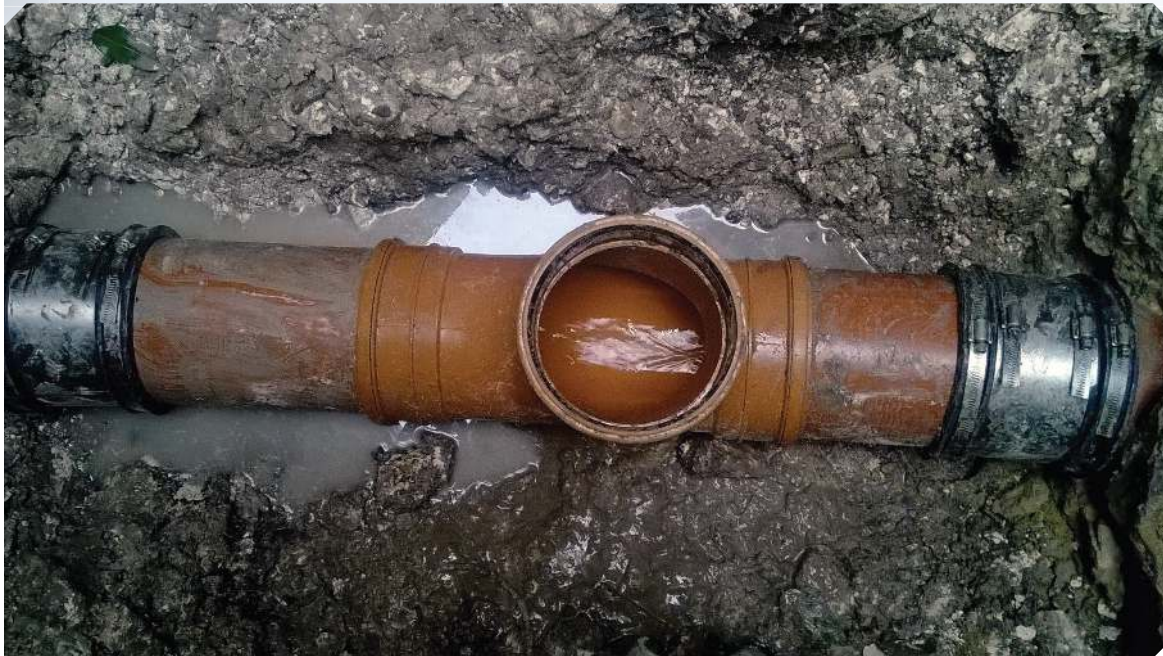
Front cover – 1. The new pipe is in place, showing free-flowing water for the first time in eight years; 2. The new manhole takes shape. [This page](#) – 1. Clever use of conveyors transported spoil from the work site; 2. Job done, the patio reinstated.

UKDN Waterflow (LG) replaced the Buchan trap with a straight section of pipe. A full-sized manhole was also installed. This gives the best maintenance access to prevent further blockage problems.
